Laboratory Corrosion Test of Steel In Concrete

State of California Department of Public Works Division of Highways

September 1968

Interim Report

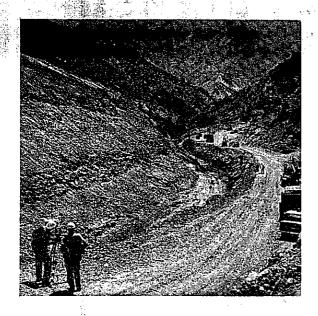
Figure 2 - Posey Canyon Channel excavation - Westward view.

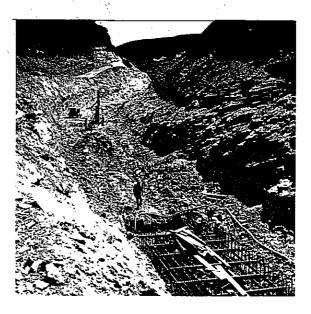
Figure 3 - Channel excavation Eastward view.

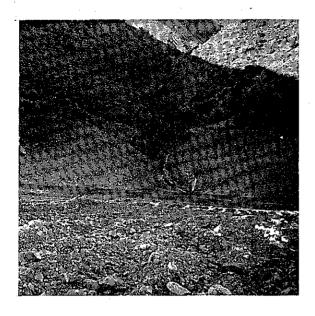
Figure 6 - Culvert inlet, photo taken from top of the embankment.

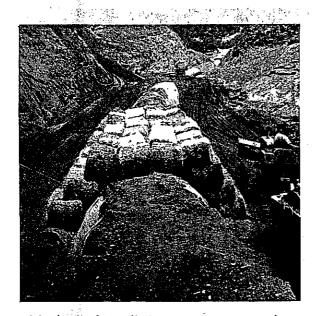
Figure 12 - Baled hay back-fill Test Station No. 5.

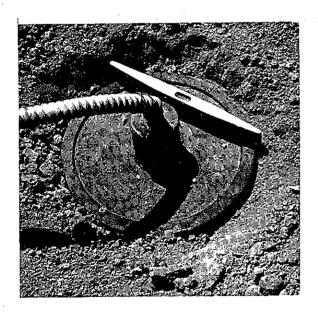
Figure 16 - Stress meter placed in the embankment to monitor earth pressure.
